Asbestos Management

8th August 2017

Thistles Shopping Centre
Goosecroft Road
Stirling
FK8 2EA

Aberdeen Standard Investments

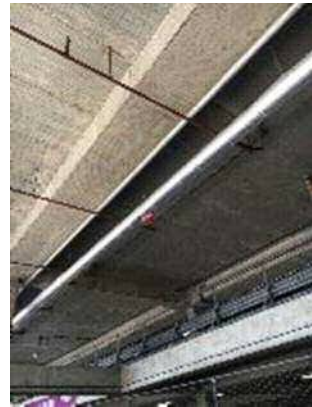
Floor	Space Reference	Findings	Photo
T2 Car Park - Ground Floor	002	<p><i>Service Yard: Concrete ceiling. Breeze block, brick, concrete and metal walls. Concrete floor. MMMF lagged metal pipes. Metal tank.</i></p> <p><i>A sample was obtained of the insulating board panels to external fire escape for independent laboratory analysis. Analysis of sample ref: TSC/SL/G/002/003 indicated this material to comprise a non-ACM.</i></p> <p><i>It is presumed that there may be gaskets present to the pipe-work. Due to health and safety reasons these could not be sampled. Further investigation will be required prior to any relevant works to this area.</i></p> <p><i>No deterioration was observed at the time of review.</i></p>

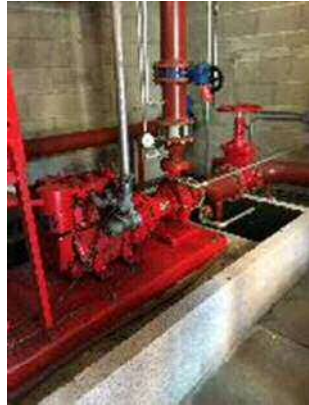
Floor	Space Reference	Findings	Photo
	003	<p><i>Sprinkler Valve Room: Timber ceiling. Breeze block walls. Concrete floor. Metal pipes. Modern electrics. Plastic downpipes.</i></p> <p><i>It is presumed that there may be gaskets present to the pipe-work. Due to health and safety reasons these could not be sampled. Further investigation will be required prior to any relevant works to this area.</i></p> <p><i>A sample was obtained of the bitumen to the floor for independent laboratory analysis. Analysis of sample ref: TSC/SL/G/003/004 indicated this material to comprise a non-ACM.</i></p> <p><i>No deterioration was observed at the time of review.</i></p>

G	Sprinkler valve room	Gaskets	NQ	Difficult	Chrysotile	Presumed	None	Sealed	4	Trivial	No deterioration observed during review	8/8/17

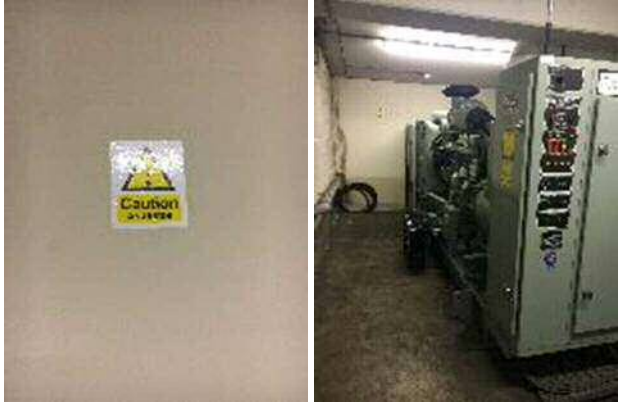
007	<p><i>T2 Generator Room: Concrete ceiling. Plasterboard, breeze block and concrete walls. Concrete floor. MMMF expansion joints. Plastic downpipe. Metal duct-work.</i></p> <p><i>It is presumed that there may be gaskets present to the generator and its associated pipe-work. Due to health and safety reasons these could not be sampled. Further investigation will be required prior to any relevant works to this area.</i></p> <p><i>Warning signage was observed to be displayed in this area.</i></p> <p><i>No deterioration was observed at the time of review.</i></p>

G	T2 Generator room	Gaskets	NQ	Difficult	Chrysotile	Presumed	None	Sealed	4	Trivial	No deterioration observed during review	8/8/17

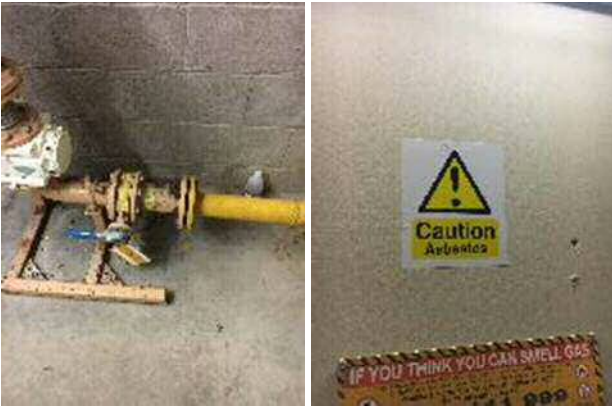
Floor	Space Reference	Findings	Photo
T2 Car Park - Ground Floor	043	<p>T2 Gas Room: Concrete ceiling. Breeze block, plasterboard and concrete walls. Concrete floor.</p> <p>A sample was obtained of the gaskets to pipe-work for independent laboratory analysis. Analysis of sample ref: TSC/SL/2/043/014 indicated this material to contain Chrysotile (white) asbestos.</p> <p>Warning signage was observed to be displayed in this area.</p> <p>No deterioration was observed at the time of review.</p>

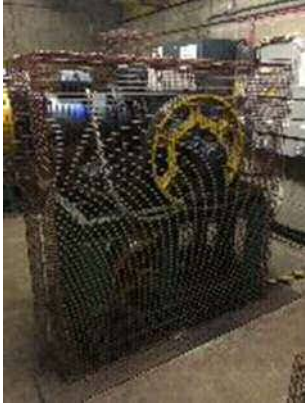
East Corridor - 3rd Floor	074	<p>Lift Motor Room Lifts 4 & 5: Metal ceiling. Breeze block and concrete walls. Concrete floor. Modern electrics. MMMF clad metal beams.</p> <p>It is presumed that there may be asbestos brake pads to lift plant. Further investigation will be required prior to any relevant works to this area.</p> <p>No deterioration was observed at the time of review.</p>

3	East corridor – Lift motor room 4 & 5	Brake Pads	NQ	Difficult	Chrysotile	Presumed	None	Sealed	4	Trivial	No deterioration observed during review	8/8/17

Part C - Overall Assessment of Risk		Trivial	
Part D - Summary of Recommendations for Control (see Asbestos Action Summary for details)			
<i>Permit to Work Procedure; Monitor condition of ACMs; Labelling; Inform; Train; Carry out further investigation prior to relevant works.</i>

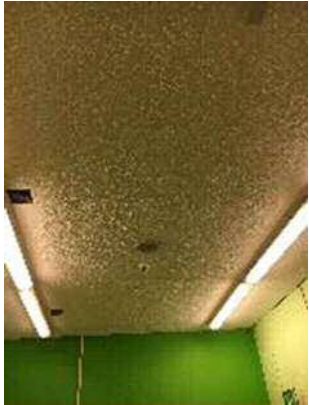
Floor	Space Reference	Findings	Photo
Shopping Mall – 2nd Floor	096	<p><i>Machine Room (Cleaners room): Concrete and plasterboard ceiling. Plasterboard, brick and concrete walls. Quarry tiled floor.</i></p> <p><i>A sample was obtained of the textured coating to the ceiling for independent laboratory analysis. Analysis of sample ref: TSC/SL/G/096/022 indicated this material to contain Chrysotile (white) asbestos.</i></p> <p><i>Warning signage was observed to be displayed in this area.</i></p> <p><i>No deterioration was observed at the time of review.</i></p>

2	Machine Room (Cleaners Room)	Textured Coating	60m ²	Medium	Chrysotile	Sampled	None	Sealed	2	Trivial	No deterioration observed during review	8/8/17

Part D - Summary of Recommendations for Control (see Asbestos Action Summary for details)			
<i>Permit to Work Procedure; Monitor condition of ACMs; Labelling; Inform; Train</i>

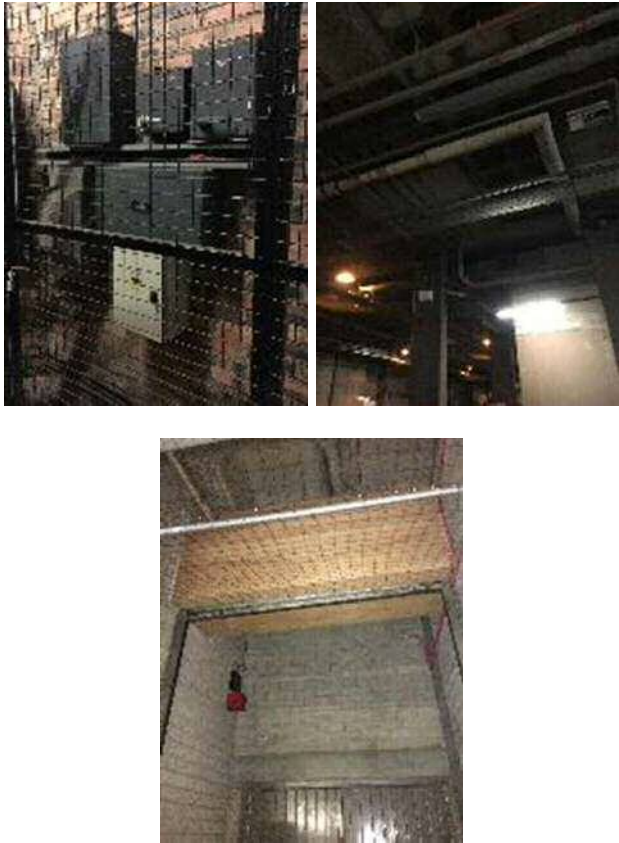
Floor	Space Reference	Findings	Photo
Basement Service Road	120	<p><i>Service Road: Metal and concrete ceiling. Breeze block, concrete and brick walls. Concrete floor. MMMF insulated pipe-work – limited access below insulation. Metal tank. Metal downpipes. Plastic pipes. Metal and timber infill panels.</i></p> <p><i>A sample was obtained of the insulating board panel to the right hand side of the goods lift for independent laboratory analysis. Analysis of sample ref: TSC/SL/B/120/031 indicated this material to contain Amosite (brown) and Chrysotile (white) asbestos.</i></p> <p><i>It was observed that this panel has been enclosed in timber boxing. Centre Management were unaware of the encapsulation and it is presumed that the insulating board panel is still present.</i></p> <p><i>It is presumed that there may be flash guards present within live electrics. Further investigation will be required prior to any relevant works to this area.</i></p> <p><i>It is presumed that there may be gaskets to insulated pipe-work. Further investigation will be required prior to any relevant works to this area.</i></p> <p><i>No deterioration was observed at the time of review.</i></p>

B	Service road	Flash-guards within electrics	NQ	Difficult	Chrysotile	Presumed	None	Sealed	4	Trivial	No deterioration observed during review	8/8/17

B	Service road	Cement board above fire-exit door	1m ²	Easy	Chrysotile	Sampled in previous survey	Major	Unsealed	N/A	N/A	This was observed to be removed however no paperwork was seen for the removal of this material	8/8/17

Permit to Work Procedure; Monitor condition of ACMs; Labelling; Inform; Train. The insulating board was observed to be encapsulated however no paper work was present for this work and management were unaware of this work. It is presumed that the insulating board is still present.

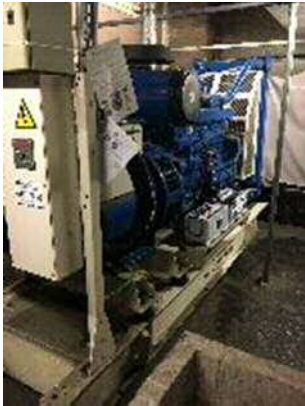
Floor	Space Reference	Findings	Photo
	126	<p><i>T1 Generator Room: Concrete and metal ceiling. Breeze block and concrete walls. Concrete floor.</i></p> <p><i>It is presumed that there may be gaskets to generator/plant. Further investigation will be required prior to any relevant works to this area.</i></p> <p><i>No deterioration was observed at the time of review.</i></p>

Part D - Summary of Recommendations for Control (see Asbestos Action Summary for details)			
<i>Permit to Work Procedure; Monitor condition of ACMs; Labelling; Inform; Train; Carry out further investigation prior to relevant works.</i>

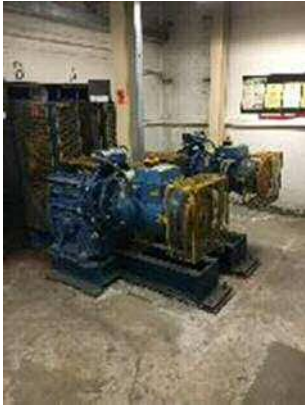
T1 Car Park – Levels 1 & 2	132	<p><i>Lift Motor Room: Concrete ceiling. Brick and concrete walls. Concrete floor. Metal beams.</i></p> <p><i>A sample was obtained of mastic to the duct-work for independent laboratory analysis. Analysis of sample ref: TSC/SL/CP/132/036 indicated this material to comprise a non-ACM.</i></p> <p><i>It is presumed that there may be brake pads to lift plant. Further investigation will be required prior to any relevant works to this area.</i></p> <p><i>No deterioration was observed at the time of review.</i></p>

Car Park level 1	T1 Car Park – Lift motor room	Brake Pads	NQ	Difficult	Chrysotile	Presumed	None	Sealed	4	Trivial	No deterioration observed during review	8/8/17

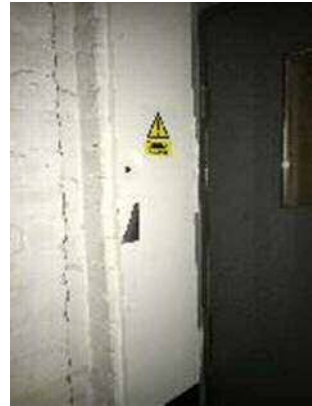
Floor	Space Reference	Findings	Photo
T1 Car Park – Levels 5 & 6	141	<p>Levels 5 & 6: Concrete ceiling. Concrete, plasterboard and timber walls. Concrete floor. Metal duct-work. Plastic pipes.</p> <p>A sample was obtained of the insulating board to the left hand side of fire escape stairs for independent laboratory analysis. Analysis of sample ref: TSC/SL/CP/141/040 indicated this material to contain Amosite (brown) and Chrysotile (white) asbestos.</p> <p>Warning signage was observed to be displayed in this area.</p> <p>No deterioration was observed at the time of review.</p>

Car Park level 5	T1 Car Park	Insulating board panel at stairs	2m ²	Easy	Amosite Chrysotile	Sampled	None	Sealed	5	Trivial	No deterioration observed during review	8/8/17

Material	Insulating board panel at stairs		
Location	Space ref: 141	Extent	2m ²
Analysis	Sampled		
Section A - Potential for Fibre Release (Material Assessment)			
Parameter	Criteria	Fibre Release Score	
Asbestos Type	Amosite & Chrysotile	2	
Product Type	Insulating Board	2	
Damage / Condition	None	0	
Surface Treatment	Sealed	1	
		Total Fibre Release Score	5
		Potential for Fibre Release	Low
Section B - Hazard Factors			
Hazard Area	Factors Taken into Consideration		
Area / Location	Internal		
Use of Area	Occupancy – High occupancy Activities carried out – Car Park Likelihood and frequency of maintenance activities – Frequent routine maintenance		
Accessibility	Easy		
Friability	Medium		
Condition	Good		
Treatment	Sealed		
Asbestos Content	Medium		
		Likelihood of Exposure:	Unlikely
Part C - Overall Assessment of Risk		Trivial	
Part D - Summary of Recommendations for Control (see Asbestos Action Summary for details)

Permit to Work Procedure; Monitor condition of ACMs; Labelling; Inform; Train

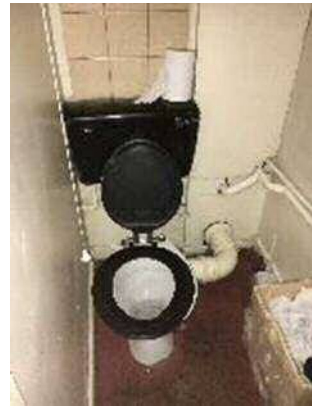
T1 Car Park – Levels 1 & 2	145	<p>Toilet: Concrete ceiling. Plasterboard, plaster and brick walls. Modern vinyl on concrete floor. Timber riser behind cistern.</p> <p>A sample was obtained of the Shires Lynx toilet cistern for independent laboratory analysis. Analysis of sample ref: TSC/SL/CP/145/042 indicated this material to contain Amosite (brown) asbestos.</p> <p>No deterioration was observed at the time of review.</p>

Material	Toilet Cistern		
Location	Space ref: 145	Extent	1 No
Analysis	<i>Sampled</i>		
Section A - Potential for Fibre Release (Material Assessment)			
Parameter	Criteria	Fibre Release Score	
Asbestos Type	<i>Amosite</i>	2	
Product Type	<i>Reinforced Composite</i>	1	
Damage / Condition	<i>None</i>	0	
Surface Treatment	<i>Sealed</i>	0	
Total Fibre Release Score		3	
Potential for Fibre Release		Very Low	
Section B - Hazard Factors			
Hazard Area	Factors Taken into Consideration		
Area / Location	<i>Internal</i>		
Use of Area	<i>Occupancy – Low occupancy Activities carried out – Maintenance activities Likelihood and frequency of maintenance activities – Infrequent maintenance</i>		
Accessibility	<i>Low</i>		
Friability	<i>Low</i>		
Condition	<i>Good</i>		
Treatment	<i>Sealed</i>		
Asbestos Content	<i>Medium</i>		
Likelihood of Exposure:		<i>Highly Unlikely</i>	
Part C - Overall Assessment of Risk		Trivial	
Part D - Summary of Recommendations for Control (see Asbestos Action Summary for details)

<i>Permit to Work Procedure; Monitor condition of ACMs; Labelling; Inform; Train</i>

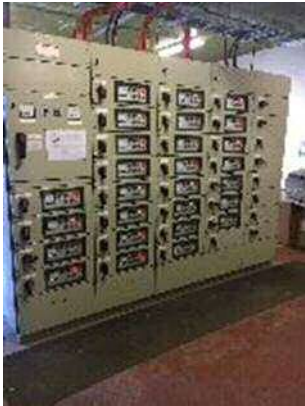
Floor	Space Reference	Findings	Photo
Roof	155	<p><i>South Switch Room: Concrete ceiling. Brick and concrete walls. Concrete floor.</i></p> <p><i>It is presumed that there may be asbestos flashguards within the live electrics. Further investigation will be required prior to any relevant works to this area.</i></p> <p><i>No deterioration was observed at the time of review.</i></p>

Part D - Summary of Recommendations for Control (see Asbestos Action Summary for details)			
<i>Permit to Work Procedure; Monitor condition of ACMs; Labelling; Inform; Train; Carry out further investigation prior to relevant works.</i>

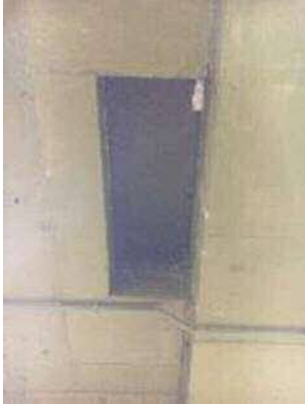
156	<p><i>Plant Room No.2: Concrete ceiling. Brick and concrete walls. Concrete floor.</i></p> <p><i>It is presumed that there may be asbestos flashguards within the live electrics. Further investigation will be required prior to any relevant works to this area.</i></p> <p><i>A sample was obtained of the cement panel to the ceiling for independent laboratory analysis. Analysis of sample ref: TSC/SL/ROOF/156/048 indicated this material to contain Chrysotile (white) asbestos.</i></p> <p><i>No deterioration was observed at the time of review.</i></p>

Roof	Plant room no. 2	Cement panel to ceiling	1m ²	Difficult	Chrysotile	Sampled	None	Unsealed	4	Trivial	No deterioration observed during review	8/8/17

Material	Cement Panel to ceiling		
Location	Space ref: 156	Extent	1m ²
Analysis	Sampled		
Section A - Potential for Fibre Release (Material Assessment)			
Parameter	Criteria	Fibre Release Score	
Asbestos Type	Chrysotile	1	
Product Type	Cement	1	
Damage / Condition	Minor	1	
Surface Treatment	Unsealed	1	
Total Fibre Release Score		4	
Potential for Fibre Release		Very Low	
Section B - Hazard Factors			
Hazard Area	Factors Taken into Consideration		
Area / Location	Internal		
Use of Area	Occupancy – Low occupancy Activities carried out – Maintenance activities Likelihood and frequency of maintenance activities – Infrequent maintenance		
Accessibility	Difficult		
Friability	Low		
Condition	Fair		
Treatment	Unsealed		
Asbestos Content	Low		
Likelihood of Exposure:		Highly Unlikely	
Part C - Overall Assessment of Risk		Trivial	
Part D - Summary of Recommendations for Control (see Asbestos Action Summary for details)

Permit to Work Procedure; Monitor condition of ACMs; Labelling; Inform; Train

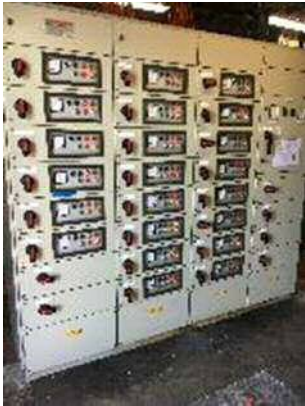
Floor	Space Reference	Findings	Photo
	157	<p><i>Plant Room No.1: Concrete ceiling. Brick and concrete walls. Concrete floor.</i></p> <p><i>It is presumed that there may be asbestos flashguards within the live electrics. Further investigation will be required prior to any relevant works to this area.</i></p> <p><i>No deterioration was observed at the time of review.</i></p>

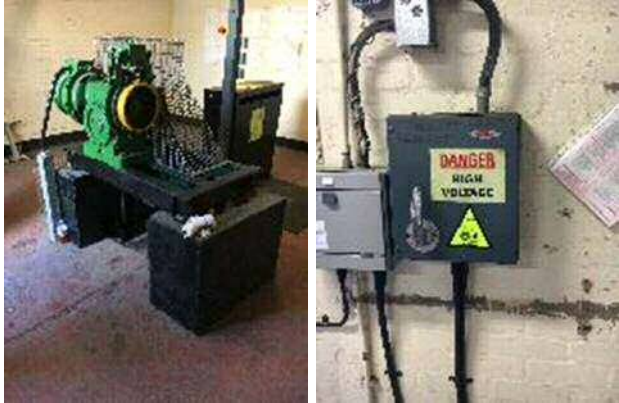
158	<p><i>Master Freeze Lift Room: Concrete ceiling. Brick and concrete walls. Concrete floor.</i></p> <p><i>It is presumed that there may be asbestos flashguards within the live electrics. Further investigation will be required prior to any relevant works to this area.</i></p> <p><i>It is presumed that there may be asbestos brake pads to the lift plant. Further investigation will be required prior to any relevant works to this area.</i></p> <p><i>No deterioration was observed at the time of review.</i></p>

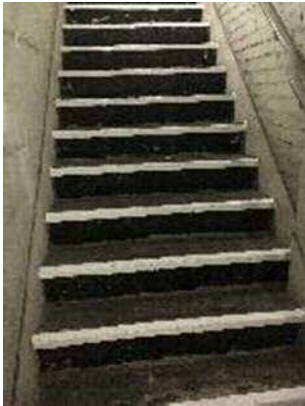
Floor	Space Reference	Findings	Photo
	166	<p><i>Fire Escape: Concrete ceiling. Breeze block walls. Concrete floor.</i></p> <p><i>A sample was obtained of the bitumen to the floor for independent laboratory analysis. Analysis of sample ref: TSC/SL/1/166/056 indicated this material to contain Chrysotile (white) asbestos.</i></p> <p><i>No deterioration was observed at the time of review.</i></p>

1	T1 toilets, rear fire escape	Bitumen to floor	10m ²	Easy	Chrysotile	Sampled	None	Composite material	2	Trivial	No deterioration observed during review	8/8/17

Material	Bitumen to floor		
Location	Space ref: 166	Extent	10m ²
Analysis	Sampled		
Section A - Potential for Fibre Release (Material Assessment)			
Parameter	Criteria	Fibre Release Score	
Asbestos Type	Chrysotile	1	
Product Type	Reinforced composite	1	
Damage / Condition	None	0	
Surface Treatment	Composite material	0	
		Total Fibre Release Score	2
		Potential for Fibre Release	Very Low
Section B - Hazard Factors			
Hazard Area	Factors Taken into Consideration		
Area / Location	Internal		
Use of Area	Occupancy – Low occupancy Activities carried out – Maintenance activities Likelihood and frequency of maintenance activities – Infrequent maintenance		
Accessibility	Difficult		
Friability	Low		
Condition	Fair		
Treatment	Unsealed		
Asbestos Content	Low		
		Likelihood of Exposure:	Highly Unlikely
Part C - Overall Assessment of Risk		Trivial	
Part D - Summary of Recommendations for Control (see Asbestos Action Summary for details)

Permit to Work Procedure; Monitor condition of ACMs; Labelling; Inform; Train

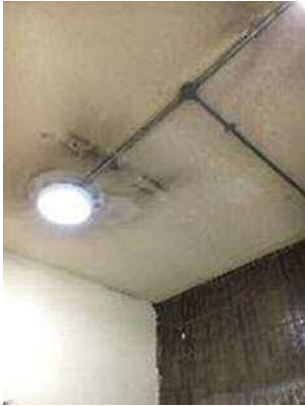
Shopping Mall - 2nd Floor	180	<p><i>Fire Escape at Help Desk: Concrete and plasterboard ceiling. Brick and concrete walls. Concrete floor.</i></p> <p><i>A sample was obtained of the textured coating to the ceiling for independent laboratory analysis. Analysis of sample ref: TSC/SL/2/180/057 indicated this material to contain Chrysotile (white) asbestos.</i></p> <p><i>No deterioration was observed at the time of review.</i></p>

2	Fire escape at help desk	Textured Coating	20m ²	Medium	Chrysotile	Sampled	None	Sealed	2	Trivial	No deterioration observed during review	8/8/17

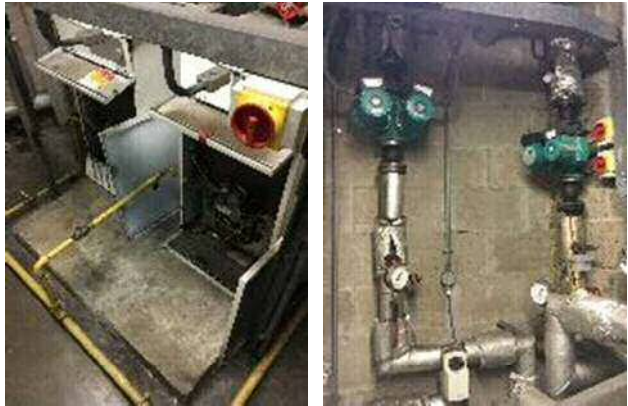
Floor	Space Reference	Findings	Photo
Management Suite	200	<p><i>Boiler Room: Concrete ceiling. Breeze block and concrete walls. Concrete floor. MMMF insulated metal pipes.</i></p> <p><i>A sample was obtained of the rope to the boiler for independent laboratory analysis. Analysis of sample ref: TSC/SL/1/200/064 indicated this material to comprise a non-ACM.</i></p> <p><i>It is presumed that there may be gaskets to the boiler and associated pipe-work. Further investigation will be required prior to any relevant works to this area.</i></p> <p><i>No deterioration was observed at the time of review.</i></p>

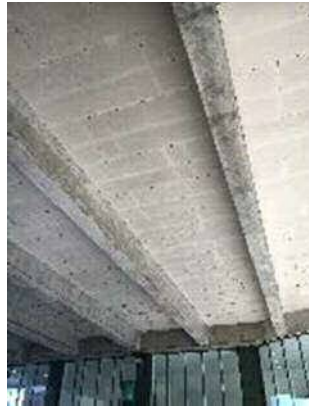
Externals		<p><i>Roof off West corridor: Metal and concrete roof. Brick and concrete walls. Metal flashings. Metal duct-work. Modern chiller units/AHU. Metal pipes. Metal fascias.</i></p> <p><i>Underside of Bridge Above Road: No access to panels. Presumed to be asbestos insulating board. Further investigation will be required prior to any relevant works.</i></p> <p><i>No deterioration was observed at the time of review.</i></p>
