S₂ Partnership Ltd
Intelligent Risk Management

Asbestos Management

17th September 2020

Thistles Shopping Centre
Goosecroft Road
Stirling
FK8 2EA

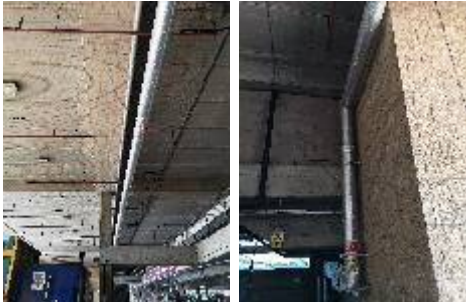
Floor	Area	Findings	Photo
Ground Floor – T2 Service Yard	002	<p>Gaskets were observed throughout this area and presume they run the length of the building; it is presumed that the gaskets contain an ACM.</p> <p>Further investigation will be required prior to any relevant works to this area.</p>

G	Sprinkler valve room	Gaskets	NQ	Difficult	Chrysotile	Presumed	None	Sealed	4	Trivial	No deterioration observed during review	17/9/20

Part D - Summary of Recommendations for Control (see Asbestos Action Summary for details)			
<i>Permit to Work Procedure; Monitor condition of ACMs; Labelling; Inform; Train; Carry out further investigation prior to relevant works.</i>

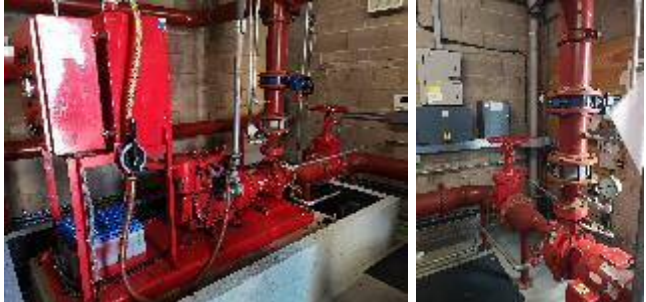
003	<p>Sprinkler valve room - gaskets were observed throughout this area and presume they run the length of the building; it is presumed that the gaskets contain an ACM.</p> <p>Further investigation will be required prior to any relevant works to this area.</p>

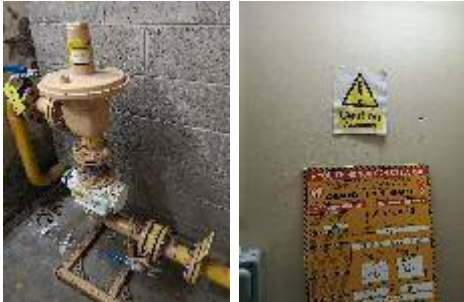
Floor	Area	Findings	Photo
<p>Ground floor – T2 Car park</p>	<p>043</p>	<p>The gas room - a sample has previously been obtained and indicates this material contains Chrysotile (white) asbestos</p> <p>Warning signage was observed to be displayed</p> <p>No deterioration was observed at this assessment</p>

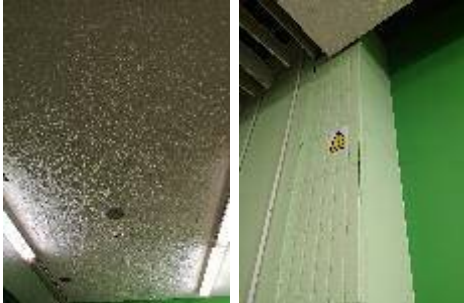
<p>Shopping mall - 2nd floor</p>	<p>096</p>	<p>Machine room (cleaners' room) - textured coating to the ceiling a sample has previously been obtained and indicates this material contains Chrysotile (white) asbestos.</p> <p>Warning signage was observed to be displayed.</p> <p>No deterioration was observed at this assessment.</p>

2	Machine Room (Cleaners Room)	Textured Coating	60m ²	Medium	Chrysotile	Sampled	None	Sealed	2	Trivial	No deterioration observed during review	17/9/20

Material	Textured Coating		
Location	Space ref: 096	Extent	60m ²
Analysis	<i>Sampled</i>		
Section A - Potential for Fibre Release (Material Assessment)			
Parameter	Criteria	Fibre Release Score	
Asbestos Type	<i>Chrysotile</i>	1	
Product Type	<i>Textured Coating</i>	1	
Damage / Condition	<i>No damage</i>	0	
Surface Treatment	<i>Sealed</i>	0	
Total Fibre Release Score		2	
Potential for Fibre Release		Very Low	
Section B - Hazard Factors			
Hazard Area	Factors Taken into Consideration		
Area / Location	<i>Internal</i>		
Use of Area	<i>Occupancy – Low occupancy</i> <i>Activities carried out – Maintenance activities</i> <i>Likelihood and frequency of maintenance activities – Frequent routine maintenance</i>		
Accessibility	<i>Difficult</i>		
Friability	<i>Low</i>		
Condition	<i>Good</i>		
Treatment	<i>Sealed</i>		
Asbestos Content	<i>Low</i>		
Likelihood of Exposure:		<i>Highly Unlikely</i>	
Part C - Overall Assessment of Risk		<i>Trivial</i>

Part D - Summary of Recommendations for Control (see Asbestos Action Summary for details)			
<i>Permit to Work Procedure; Monitor condition of ACMs; Labelling; Inform; Train</i>

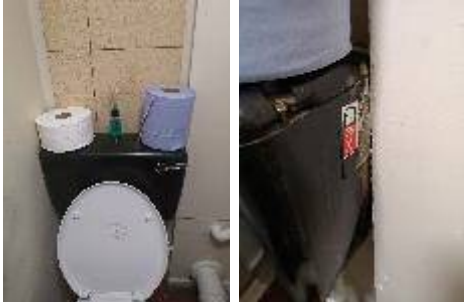
T1 Car park – level 1&2	145	<p><i>The toilet cistern has previously been taken of the insulating board and indicates this material contains Amosite (brown) asbestos</i></p> <p><i>Warning signage was observed to be displayed</i></p> <p><i>No deterioration was observed at this assessment</i></p>

Material	Toilet Cistern		
Location	Space ref: 145	Extent	1 No
Analysis	<i>Sampled</i>		
Section A - Potential for Fibre Release (Material Assessment)			
Parameter	Criteria	Fibre Release Score	
Asbestos Type	<i>Amosite</i>	2	
Product Type	<i>Reinforced Composite</i>	1	
Damage / Condition	<i>None</i>	0	
Surface Treatment	<i>Sealed</i>	0	
Total Fibre Release Score		3	
Potential for Fibre Release		Very Low	
Section B - Hazard Factors			
Hazard Area	Factors Taken into Consideration		
Area / Location	<i>Internal</i>		
Use of Area	<i>Occupancy – Low occupancy</i> <i>Activities carried out – Maintenance activities</i> <i>Likelihood and frequency of maintenance activities – Infrequent maintenance</i>		
Accessibility	<i>Low</i>		
Friability	<i>Low</i>		
Condition	<i>Good</i>		
Treatment	<i>Sealed</i>		
Asbestos Content	<i>Medium</i>		
Likelihood of Exposure:		<i>Highly Unlikely</i>	
Part C - Overall Assessment of Risk		Trivial

Part D - Summary of Recommendations for Control (see Asbestos Action Summary for details)			
<i>Permit to Work Procedure; Monitor condition of ACMs; Labelling; Inform; Train</i>

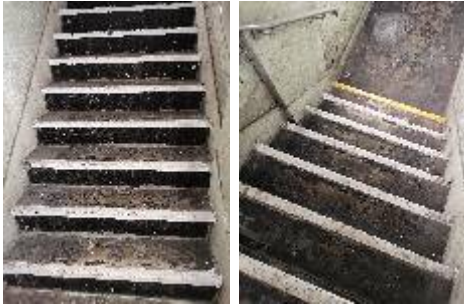
166	<p>Fire exit staircase from WCs – Service yard - staircase bitumen has previously been sampled and indicates this material to contain Chrysotile (white) asbestos</p> <p><i>No deterioration was observed at this assessment</i></p>

1	T1 toilets, rear fire escape	Bitumen to floor	10m ²	Easy	Chrysotile	Sampled	None	Composite material	2	Trivial	No deterioration observed during review	17/9/20

Material	Bitumen to floor		
Location	Space ref: 166	Extent	10m ²
Analysis	<i>Sampled</i>		
Section A - Potential for Fibre Release (Material Assessment)			
Parameter	Criteria	Fibre Release Score	
Asbestos Type	<i>Chrysotile</i>	1	
Product Type	<i>Reinforced composite</i>	1	
Damage / Condition	<i>None</i>	0	
Surface Treatment	<i>Composite material</i>	0	
Total Fibre Release Score		2	
Potential for Fibre Release		Very Low	
Section B - Hazard Factors			
Hazard Area	Factors Taken into Consideration		
Area / Location	<i>Internal</i>		
Use of Area	<i>Occupancy – Low occupancy</i> <i>Activities carried out – Maintenance activities</i> <i>Likelihood and frequency of maintenance activities – Infrequent maintenance</i>		
Accessibility	<i>Difficult</i>		
Friability	<i>Low</i>		
Condition	<i>Fair</i>		
Treatment	<i>Unsealed</i>		
Asbestos Content	<i>Low</i>		
Likelihood of Exposure:		<i>Highly Unlikely</i>	
Part C - Overall Assessment of Risk		Trivial

Part D - Summary of Recommendations for Control (see Asbestos Action Summary for details)			
<i>Permit to Work Procedure; Monitor condition of ACMs; Labelling; Inform; Train</i>

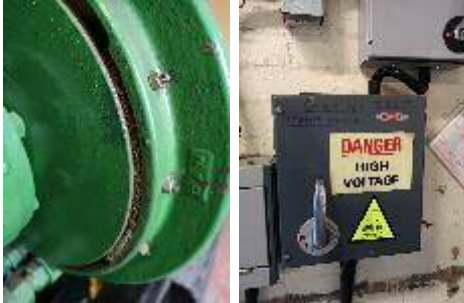
158	<p>Master freeze Lift Room - It is presumed that the dated electrical boxes contain an ACM further investigation is required. It is presumed that there may be asbestos brake pads to the lift plant. Further investigation will be required prior to any relevant works to this area.</p> <p>No deterioration was observed at this assessment.</p>

Material	Brake Pads		
Location	Space ref: 158	Extent	NQ
Analysis	Presumed		
Section A - Potential for Fibre Release (Material Assessment)			
Parameter	Criteria	Fibre Release Score	
Asbestos Type	Chrysotile	1	
Product Type	Textile	2	
Damage / Condition	No damage	0	
Surface Treatment	Sealed	1	
		Total Fibre Release Score	4
		Potential for Fibre Release	Very Low
Section B - Hazard Factors			
Hazard Area	Factors Taken into Consideration		
Area / Location	Internal		
Use of Area	Occupancy – Low occupancy Activities carried out – Maintenance activities Likelihood and frequency of maintenance activities – Infrequent maintenance		
Accessibility	Difficult		
Friability	Low		
Condition	Good		
Treatment	Sealed		
Asbestos Content	High		
		Likelihood of Exposure:	Highly Unlikely
Part C - Overall Assessment of Risk		Trivial	
Part D - Summary of Recommendations for Control (see Asbestos Action Summary for details)			
Permit to Work Procedure; Monitor condition of ACMs; Labelling; Inform; Train; Carry out further investigation prior to relevant works.

Part D - Summary of Recommendations for Control (see Asbestos Action Summary for details)			
<i>Permit to Work Procedure; Monitor condition of ACMs; Labelling; Inform; Train; Carry out further investigation prior to relevant works.</i>

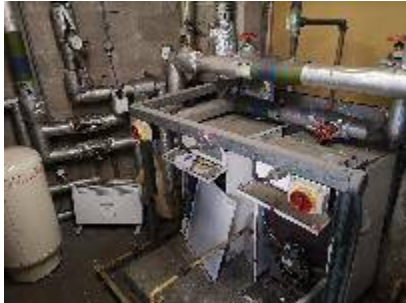
Management suite	200	<p>Boiler room - it is presumed the pipework gaskets contains an ACM further investigation is required.</p>

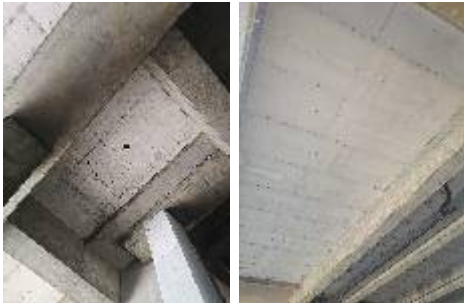
Floor	Area	Findings	Photo
Externals		<p><i>Underside of the bridge above the road - no access to the panels on this assessment and are presumed to contain an ACM further investigation required.</i></p> <p><i>Some deterioration was observed at this assessment.</i></p>

Occupant Details:			Thistles Shopping Centre								Comments / Notes		
Floor	Room	Product Type	Extent	Accessibility	Asbestos type	Identification Level	Damage	Surface Treatment	Total Fibre Release Score	Overall Assessment of Risk	(inc. Updated information)	Date	Photo
1	Management suite Boiler room	Gaskets	NQ	Difficult	Chrysotile	Presumed	None	Sealed	4	Trivial	No deterioration observed during review	17/9/20	 
Ext.	External road	Insulating board to underside of bridge	NQ	Difficult	Amosite	Presumed	None	Sealed	7	Low	Minor deterioration observed.	17/9/20

Material	Insulating board to underside of bridge		
Location	Space ref: External	Extent	NQ
Analysis	Presumed		
Section A - Potential for Fibre Release (Material Assessment)			
Parameter	Criteria	Fibre Release Score	
Asbestos Type	Amosite	2	
Product Type	Insulating board	2	
Damage / Condition	Low	1	
Surface Treatment	Unsealed	2	
Total Fibre Release Score		7	
Potential for Fibre Release		Medium	
Section B - Hazard Factors			
Hazard Area	Factors Taken into Consideration		
Area / Location	External		
Use of Area	Occupancy – Low occupancy Activities carried out – None Likelihood and frequency of maintenance activities – Unlikely		
Accessibility	Difficult		
Friability	Medium		
Condition	Fair		
Treatment	Unsealed		
Asbestos Content	Medium		
Likelihood of Exposure:		Highly Unlikely	
Part C - Overall Assessment of Risk		Tolerable	
Part D - Summary of Recommendations for Control (see Asbestos Action Summary for details)

Permit to Work Procedure; Monitor condition of ACMs; Labelling; Inform; Train; Carry out further investigation prior to relevant works.
